CITY OF ROCHELLE TAX INCREMENT FINANCING ELIGIBILITY FINDINGS

Downtown / Southern Gateway TIF District

DRAFT REPORT

Prepared by Teska Associates, Inc.

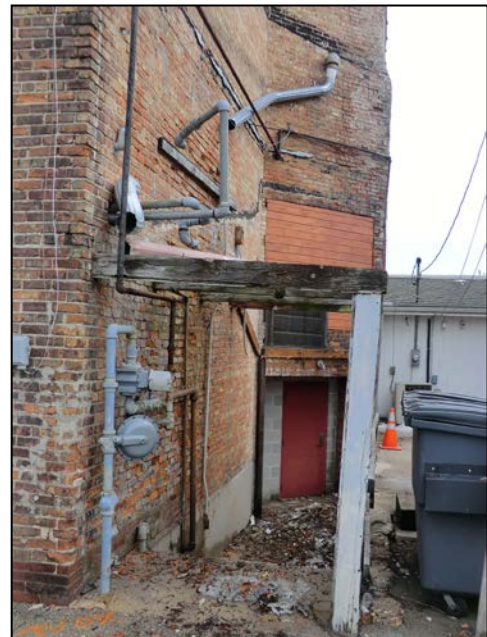
There are a number of dilapidated structures within the Project Area, particularly in the downtown area as well as accessory buildings (sheds, garages, etc.) throughout the Project Area. However, instances of dilapidation are widespread or evenly distributed throughout the entire Project Area to a degree as to be a qualifying factor towards eligibility of the Project Area as a "conservation area."

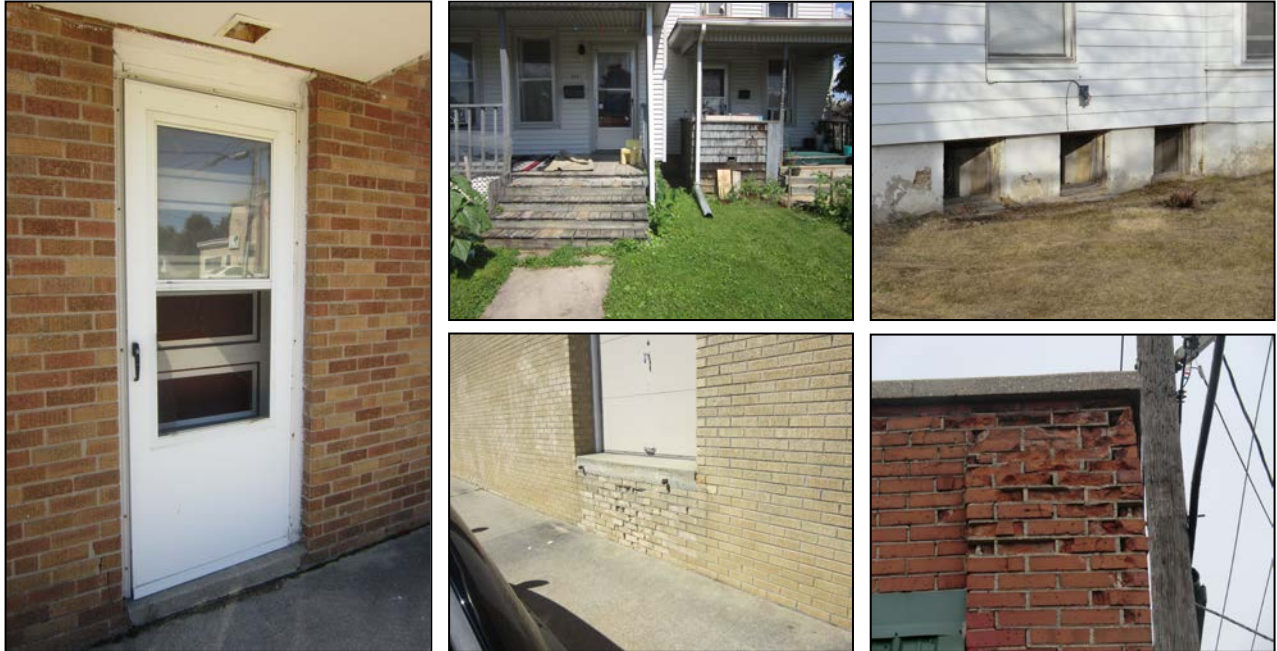
Deterioration of buildings and site improvements is widespread and evenly distributed throughout the entire Project Area. Common building issues include deteriorating doors and windows, roofs, gutters and downspouts, porches and patios, and crumbling masonry. Common issues relating to surface improvements include deterioration of paved parking areas, potholes in roadways, cracks in curbs, and fencing. Out of 457 total parcels within the Project Area, a total of 352 parcels (77%) exhibit some type of building and/or site deterioration.

Examples of Building Deterioration

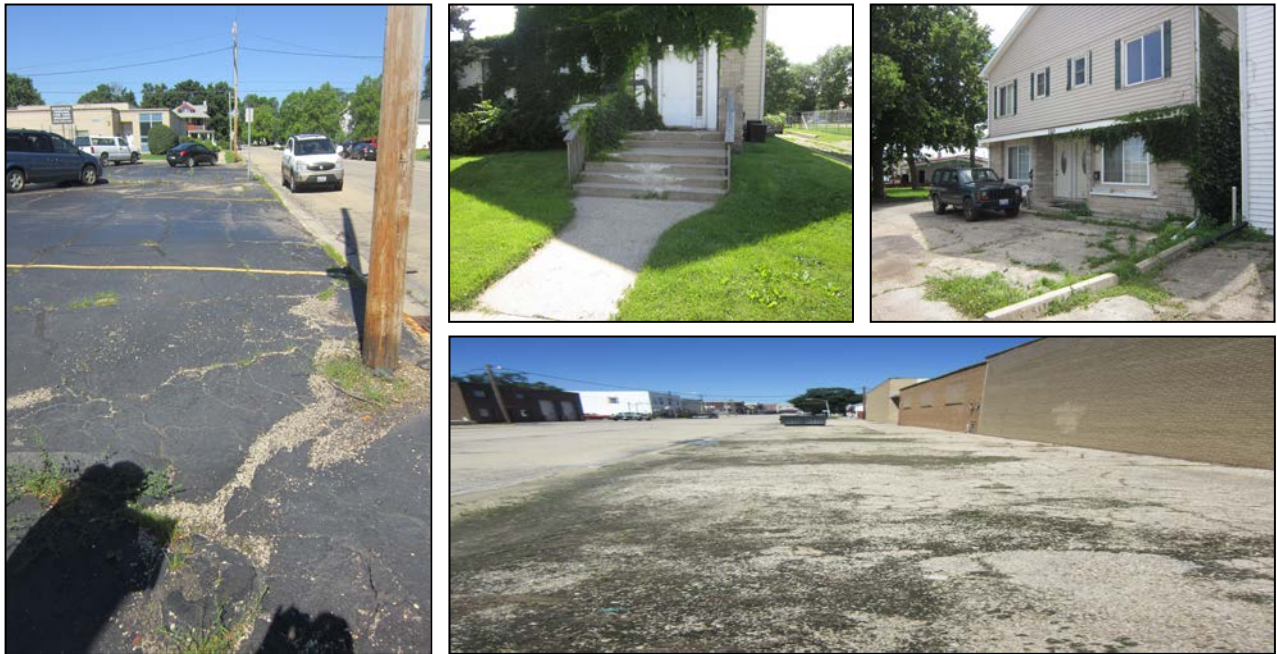
Examples of Site Deterioration

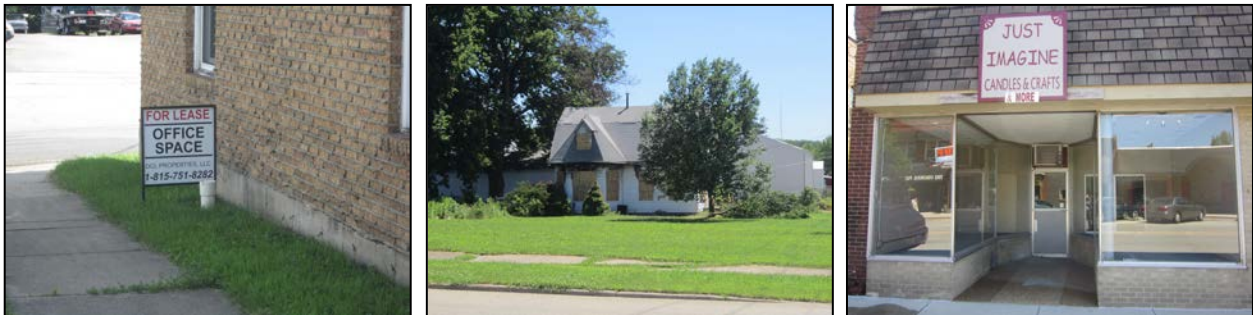
Instances of vacant or partially vacant structures are present throughout the Project Area. Vacancies primarily consist of commercial buildings within the downtown area, as well as isolated industrial and residential buildings. Observations during the field study indicate that accessory residential uses (apartments) may also exhibit high levels of vacancy. However, verification of residential occupancy rates is difficult to verify and unavailable at the time of this report.

Although vacancies are present throughout the Project Area, they are not present to such a high degree or so widely distributed as to be considered a qualifying factor towards designation of the Project Area as a “conservation area.”

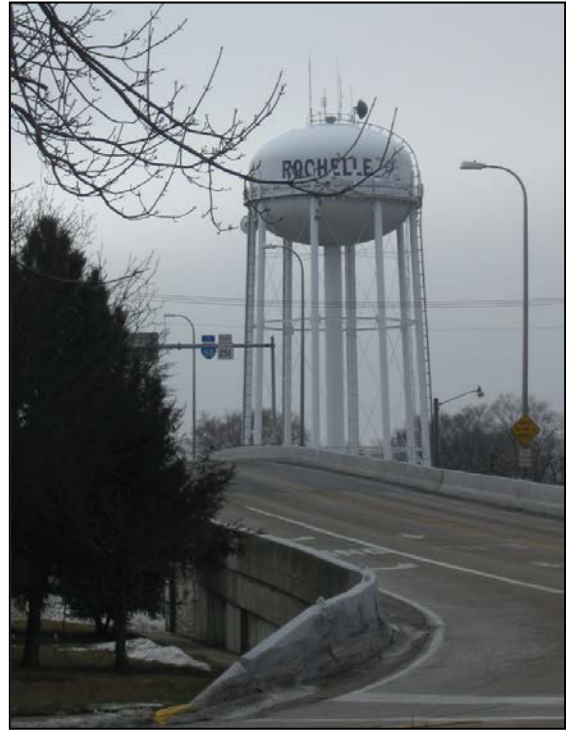
The Project Area contains widespread instances of inadequate utilities. Based on information provided by the City, significant roadway improvements are necessary throughout the Project Area. Water mains are undersized and in need of replacement. Sanitary sewer lines are over 100 years old and need to be replaced as roadway improvements are completed. The current low voltage electric service is also inadequate throughout the RFP. **Due to the amount of infrastructure upgrades required and widespread distribution of such upgrades, inadequate utilities is a significant contributing factor towards designation of the Project Area as a “conservation area.”**

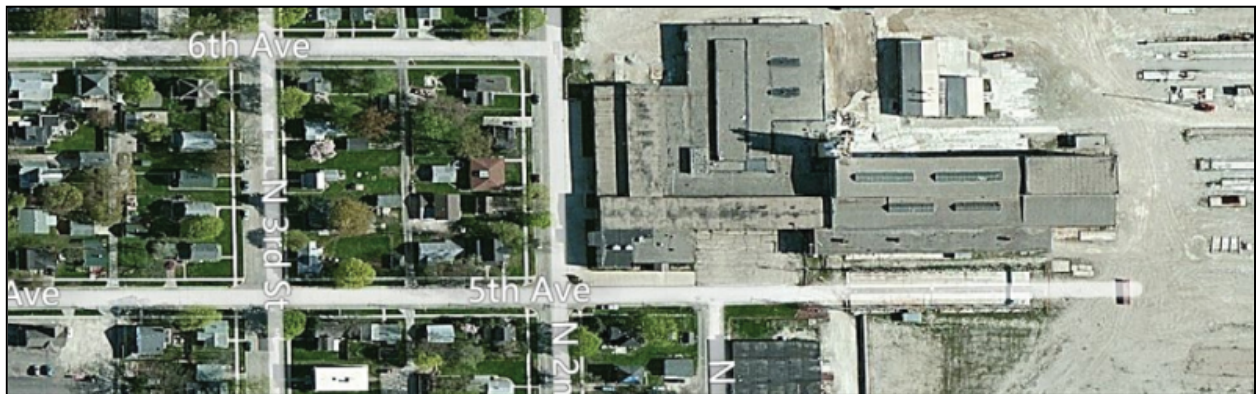
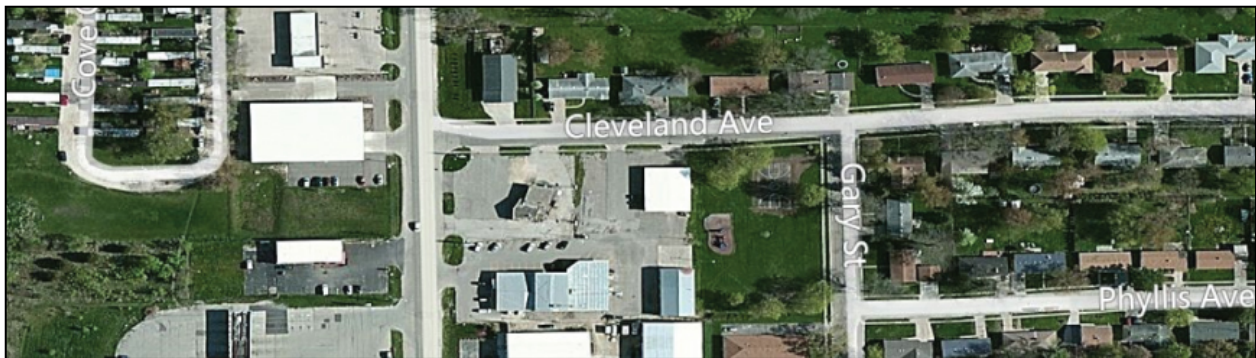
The Project Area contains a mix of downtown commercial retail, residential, institutional and industrial uses. Residential uses adjacent to industrial uses are common and widely distributed throughout the Project Area. **Therefore, deleterious land use or layout is considered a significant contributing factor towards designation of the Project Area as a “conservation area.”**

Examples of Incompatible Land Use Relationships
